NZ Hydraulic Sluices and IHC Jigs in Placer Mining in the Bugant Goldfield of Mongolia

Gerrit Bazuin (1) & Dr. Baatar Tumenbayar (2)

ABSTRACT

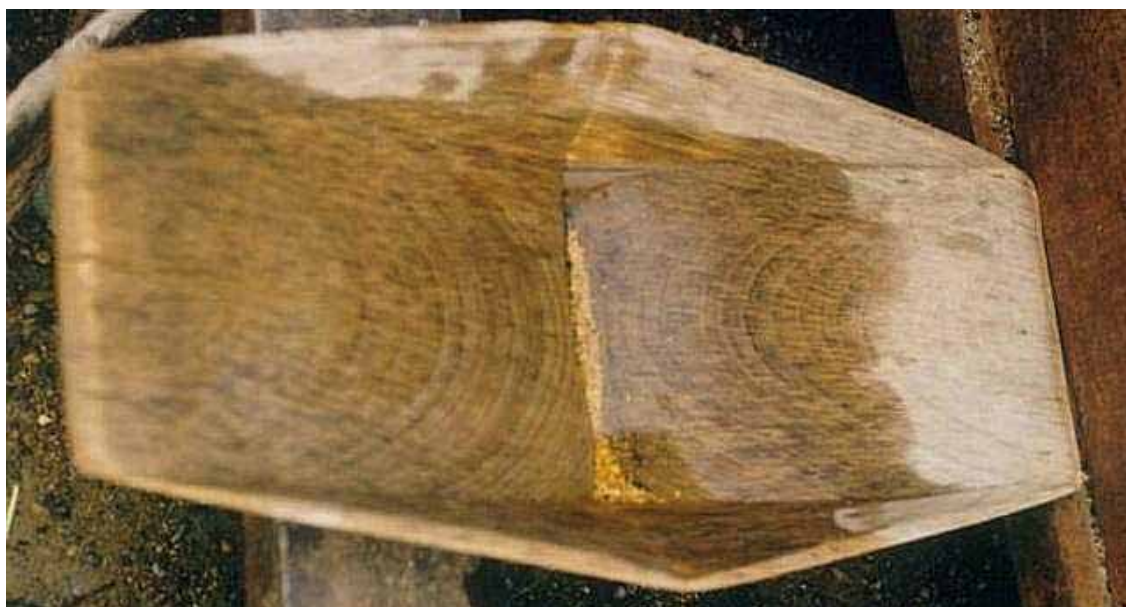
Fig.1: Gold recovered at Bugant Mine by the 25m³/hour PAuSE Hydraulic Riffled Sluice from New Zealand, revealed by upgrading in a traditional Siberian wooden gold pan.

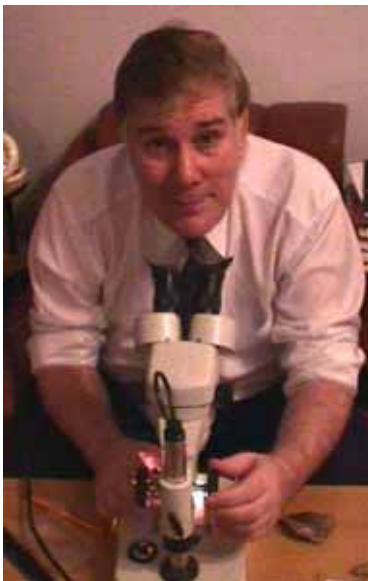
Fig.3: Wessex WZ1 Zoom Stereo Microscope in use in Mongolia by Robin Grayson, General Director of Eco-Minex International Ltd.

24 samples were bagged, washed, panned and tested for heavy mineral concentrates (black sands). The concentrates were identified using a Wessex Micro model WZ1 Binocular Microscope (x40) fitted with stereo-zoom and variable-control built-in halogen illumination (option of reflected and transmitted light) with 220v-240v, 50/60 Hz mains electrical supply. An eyepiece micrometer was inserted.

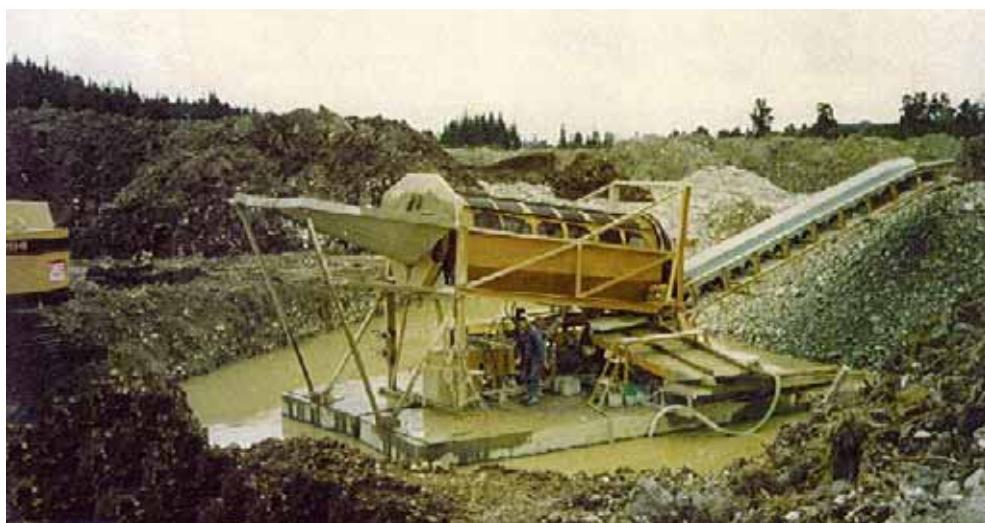
Fig.6: NZ Hydraulic Riffled Sluices, mounted on a pontoon in New Zealand. (photo: courtesy of Jim Loveridge)

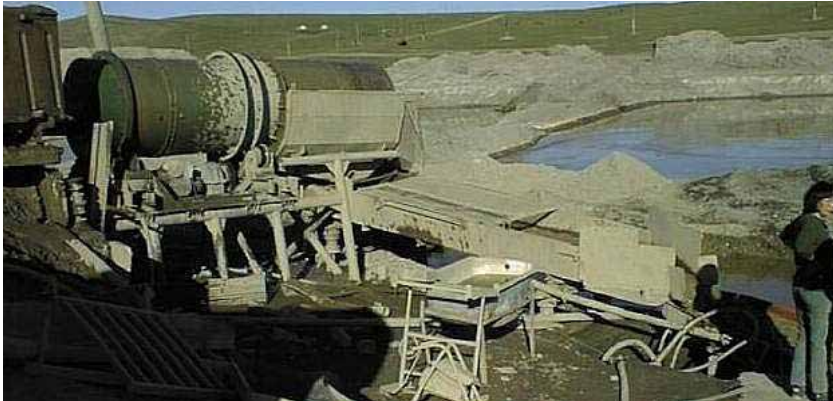
Fig. 7: Russian-style trommel and Russian-style sluice at the Delger-Ech Mine in the Sergelen Goldfield near Ulaanbaatar. Note the very large amount of sticky pervasive clay.

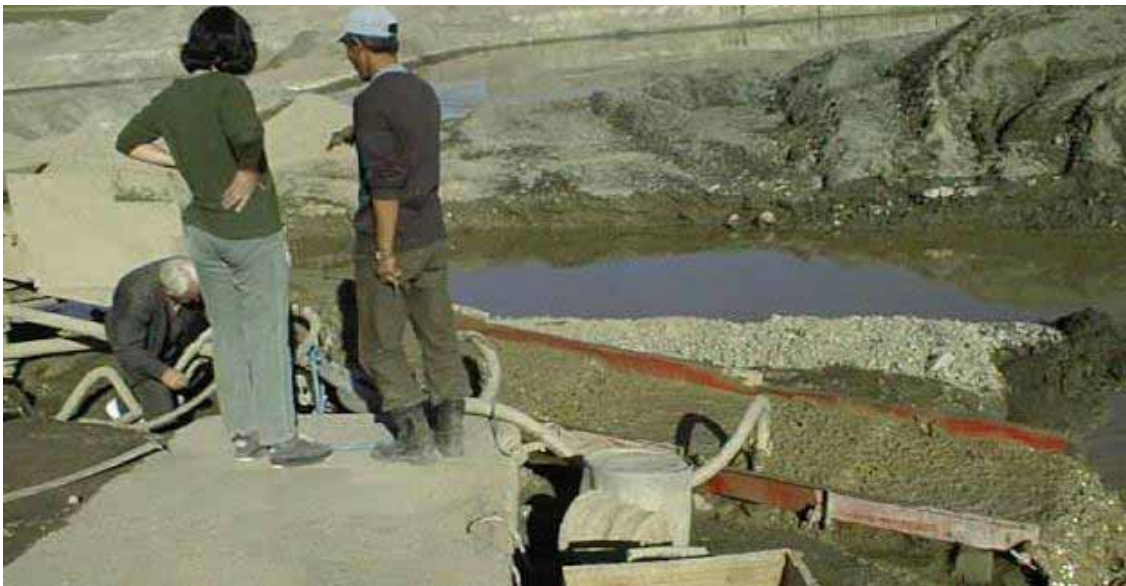
Fig.8: 25m³/hour PAuSE NZ Hydraulic Riffled Sluice in action in the Sergelen Goldfield at the Delger-Ech Mine. Note the 'steps' and bowing of the sluice due to lack of a supporting frame.

The NZ Hydraulic Riffled Sluice was effective in catching a significant amount of gold otherwise lost in the tailings by the Russian-style sluice in the Delger-Ech Mine. However the test was abandoned after a few weeks, due to: a) the massive clay content adversely affecting performance; b) inexperience of mine operatives in the novel equipment; c) malfunctioning due to the lack of a supporting frame beneath the sluice; d) lack of clean water essential for the boil boxes (200 litres/minute @ 15-35 kpa pressure) and for the 2 sets of hydraulic riffles (2 x 650 litres/minute @ 15-35 kpa pressure).

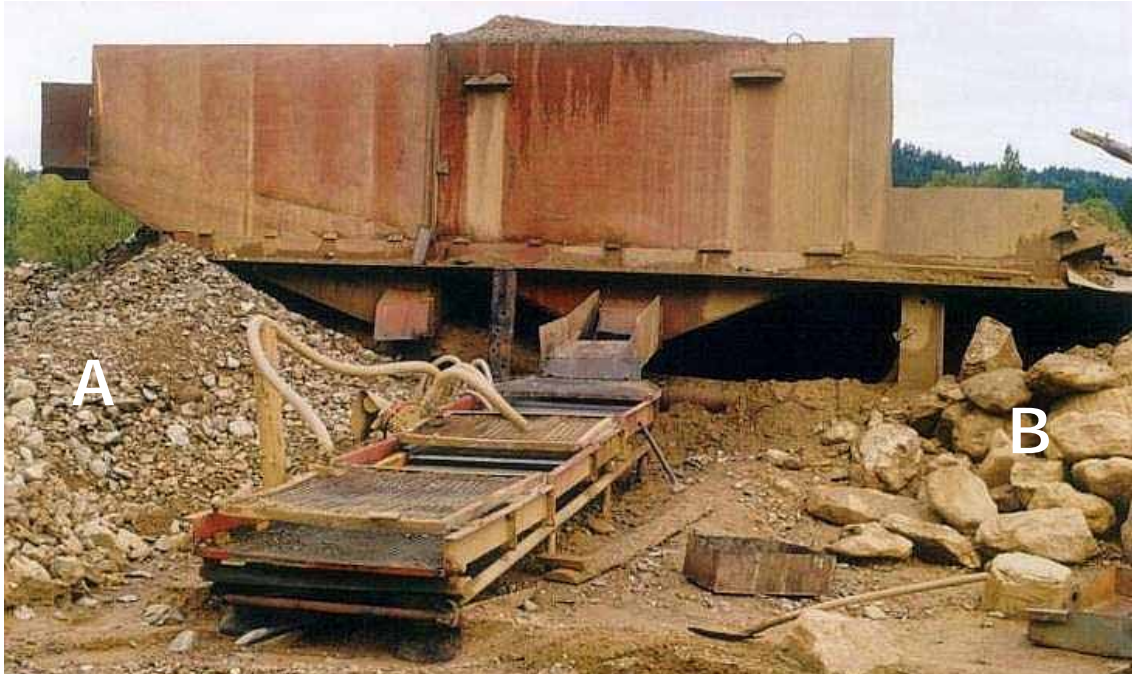
Fig.9: 25m³/hour PAuSE NZ Hydraulic Riffled Sluice fed via a link chute from a Russian-style static screen blasted by water cannon (right). A = a cone of oversize from the tail-gate of the screening box. B = large oversize manhandled away by the water cannon operator.

At the Bugant Mine, it was decided to feed the 25m³/hour PAuSE NZ Hydraulic Riffled Sluice directly by slurry from a static screen (40-50mm holes) blasted by a conventional Russian-style water cannon ('monitor'), dispensing altogether with a Russian sluice:

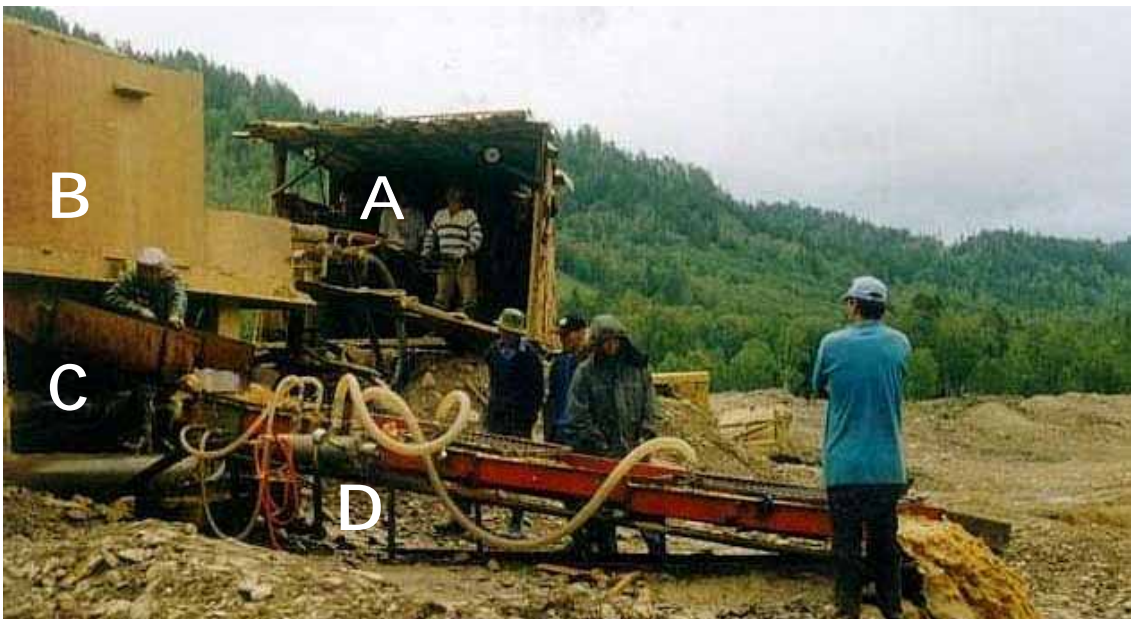
Fig.10: A Russian water cannon 'monitor' (A) blasting pay-gravels above a static screen (B), feeding slurry via a link chute (C) to the 25m³/hour PAuSE NZ Hydraulic Riffled Sluice (D).

A tubular steel support was added to inhibit bowing of the NZ Hydraulic Riffled Sluice:

From the outset, the addition of the tubular welded steel frame was successful in ensuring that the PAuSE NZ Hydraulic Riffled Sluice maintained the specified optimum angle of 8 degrees, confirmed frequently with a calibrated spirit level.

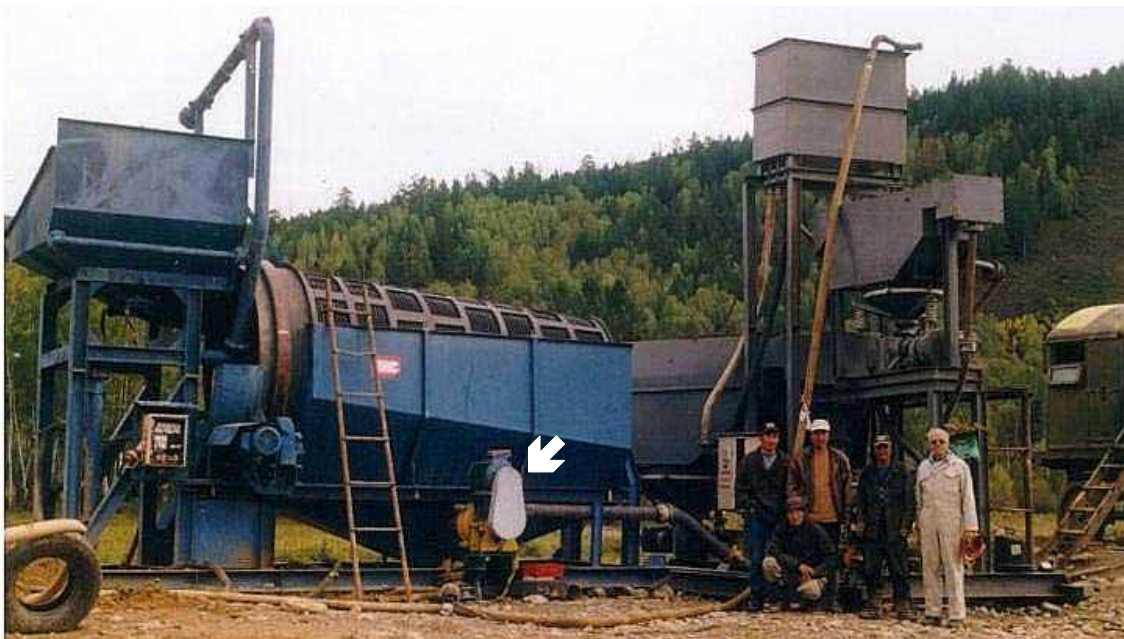
Fig.11: Frank M^cBride (right) with team at the Bugant Mine, having completed the electrical wiring of the IHC 2-Cell Jig (right) and the IHC Conical Screen (left). Note the Warman Pump (arrow) for pumping slurry by pipeline from the screen to the jig.

For the 2001 mining season, Ochir placed at the Bugant Mine an IHC 2-Cell Sawtooth Trapezoidal Jig fed by slurry pumped by a Warman pump from an IHC Conical Screen ("scrubber") with 35mm x 12mm slots. The equipment was trucked from Ulaanbaatar and erected at the Bugant Mine at the start of July 2001, far later in the season than hoped for, but delayed due to the change of ownership of the mining license.

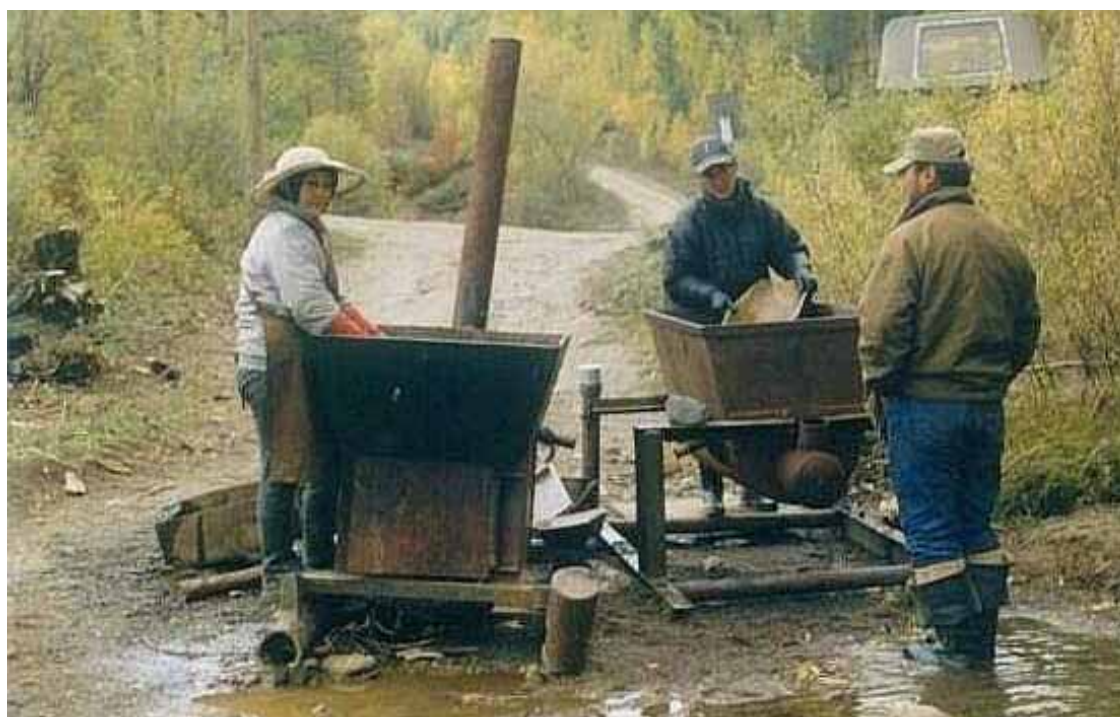
Fig.12: Upgrading concentrates by panning, led by the Chief Panner Mrs. Jadamba (left). A security guard looks on. The water is warmed by wood-fired boilers for comfort and accuracy.

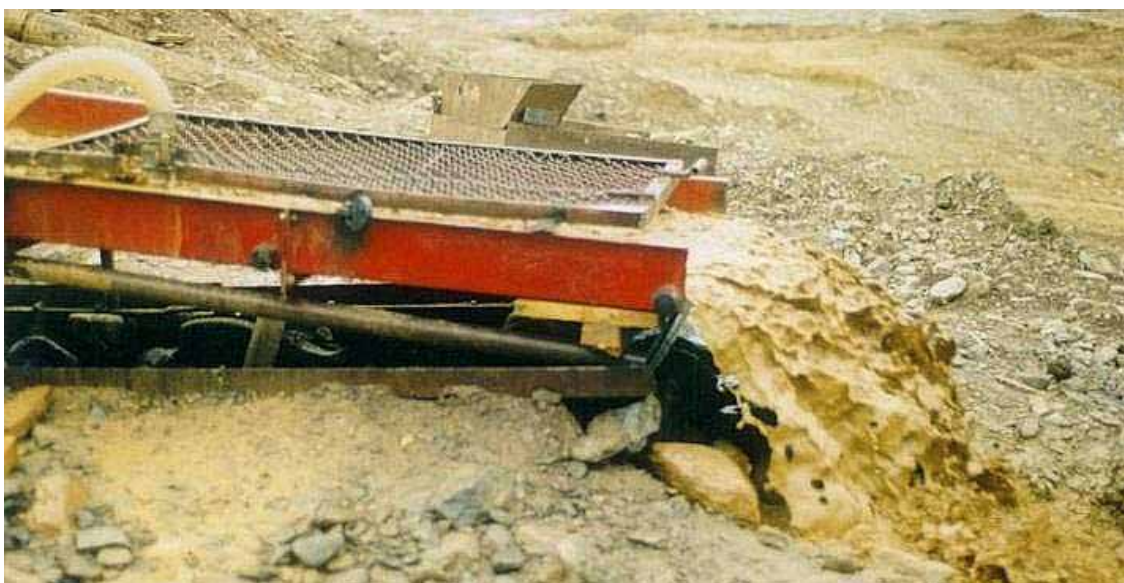
Fig.13: 25m³/hour PAuSE NZ Hydraulic Riffled Sluice in action at the Bugant Mine. Note the high clay content of the slurry.

The daily cycle began with cleaning the 2 hydraulic sluice sections by removing the NOMADTM matting (backless type) for careful washing off of the concentrate, for taking to the panning area for upgrading. The plan had been to operate the PAuSE NZ Hydraulic Riffled Sluice for 20 hours a day, but as discussed later, this was rarely achieved due to problems in trucking enough placer, and thus the sluice averaged only about 8 hours a day. Daily production from the 25m³/hour PAuSE NZ Hydraulic Riffled Sluice varied from 80 to 180 grams/day, largely dependent upon the volume of feed in the operating hours achieved.

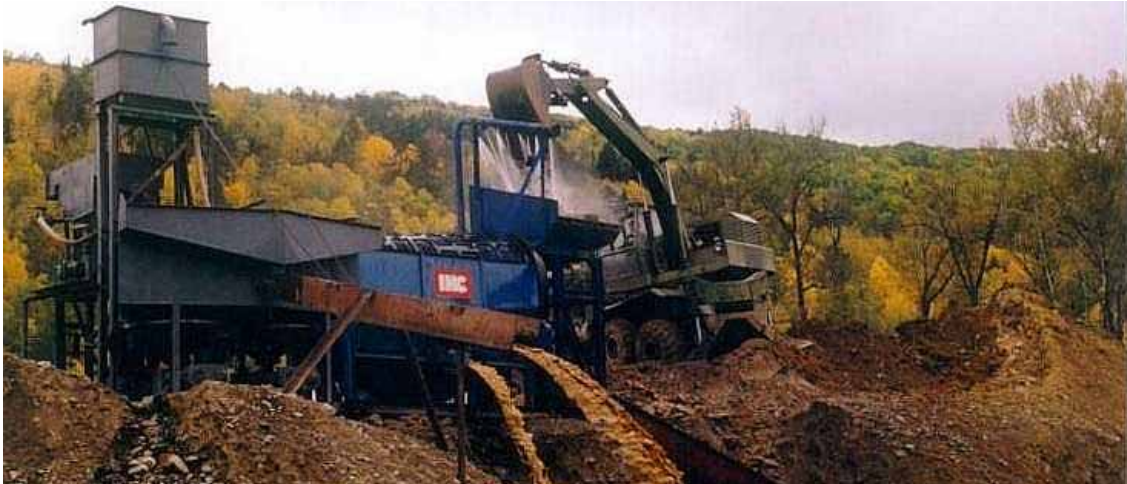
Fig.14: Ex-Soviet military 6-wheeled excavator (right) with 600-litre bucket dumping gravel into water-jetted Grizzly of IHC Conical Screen, feeding slurry to an IHC 2-Cell Jig (left) at the Bugant Mine. Note the clayey tailings issuing from the jig and water+oversize from the screen.

The volume of placer supplied to the IHC Conical Screen (‘scrubber’) feeding the IHC 2-Cell Jig was grossly inadequate. This was due to breakdowns of the contract-hired trucks and excavators. Priority was given to supplying the PAuSE NZ Hydraulic Riffled Sluice. Consequently the gold recovery achieved by the IHC 2-Cell Jig could not be assessed.

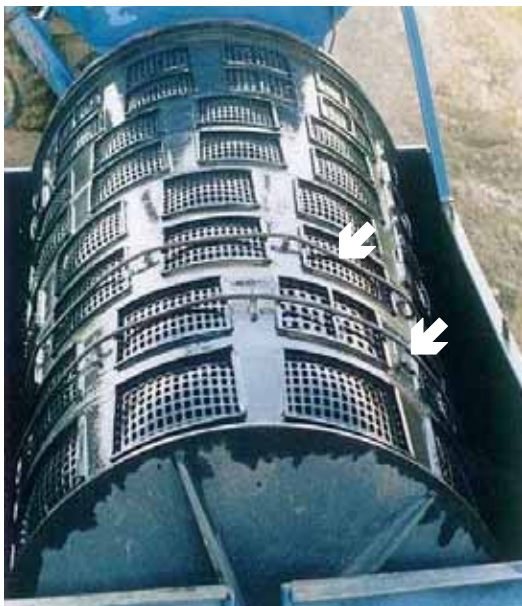
Fig.15: IHC Conical Screen showing outward buckling of the screen plates due to battering by slabs of oversize that got past the Grizzly. Arrows show the welded-on metal rods to prevent further buckling of screen plates.

A problem arose with the IHC Conical Screen. This operated at only 10-15m³/hour instead of 60-80m³/hour to minimise damage, allow clay to fall through the Grizzly and to ensure enough residence time in the Scrubber for the clay to disaggregate into the slurry. The damage was inflicted by slabs of rock that got through the Grizzly sideways and so entered the screen, bending many plates, and ‘popping off’ some. Emergency repairs were made by Ochir staff, requiring about 8 hours of downtime. Loose plates were straightened and re-inserted, and 12mm steel rods welded on to inhibit buckling. An issue was the slots in the screen plates being 35 x 12 mm - permitting feed to be larger than recommended for optimal jig performance.

Halving the 185mm gaps between the Grizzly Bars protecting the IHC Conical Screen was desirable, but no suitable steel was available locally. This is now expected to be done in the winter months, together with steepening the angle of the Grizzly in order to throw-off the larger slabs of rock. It would be preferable to change the slots to closer to the recommended 25mm maximum feed, still capable of recovering all but the very largest gold nuggets.

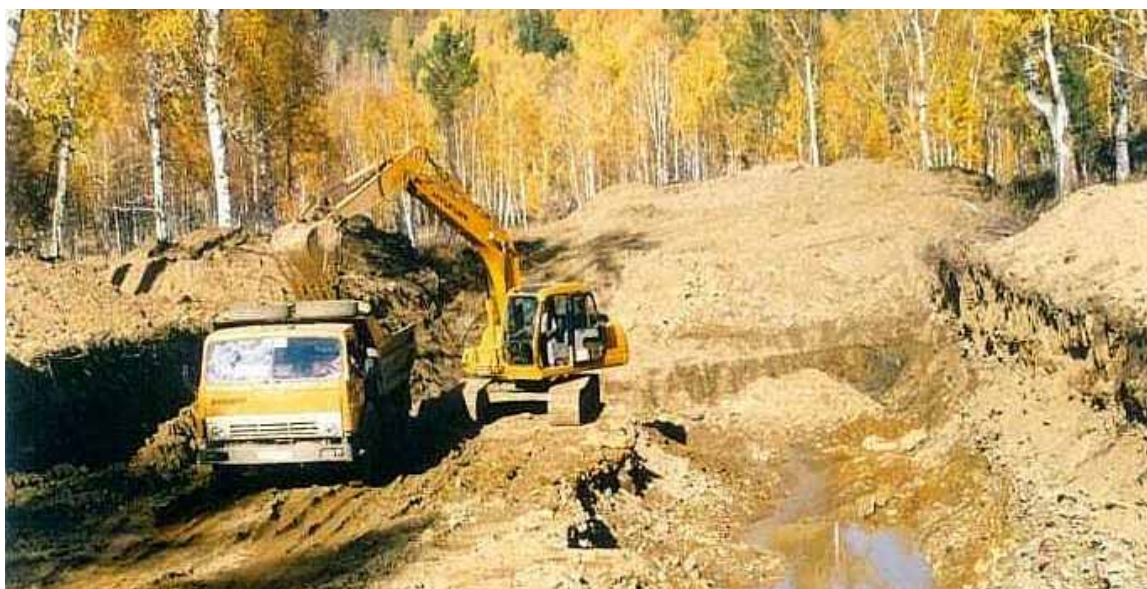
Fig.16: Korean Hyundai caterpillar-tracked excavator loading a Russian Kraz 5m³ truck with placer at the Bugant Mine in 2001. The lack of clearance of trees and scrub was due to a decision to attempt high-grading at this location. The perpetuation of the Russian-style bulldozing of overburden into the forest destroyed 50% more trees than needs be, buried topsoil and sterilised some placer reserves. An influx of groundwater is invading the excavated area, counteracted by pumping.

Mining of the placer then commenced. An excavator was used to excavate the placer and load it into a waiting truck. The choice of route of the truck to the washing plants was restricted by the linear mounds of bulldozed overburden/topsoil above the north and south edges of the pit walls. Haulage was therefore confined to trucking along the top of the yet-to-be-mined placer. A further obstacle to haulage was exerted by a 4m deep trench, incised into the placer to facilitate drainage from the active mining area westwards into the tailings ponds.
