World Placer Journal - 2003 - Volume 3.

Potential of satellite images for monitoring placer gold mining in Mongolia

Robin Grayson¹

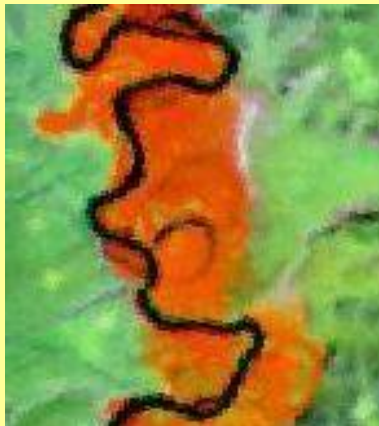
AN UN-MINED STRETCH OF THE TUUL VALLEY ...

A typical stretch of the Tuul River outside the mining area, showing undisturbed lush damp grasslands (red) and scattered ox-bow ponds. The river is flowing from the south (bottom of image).

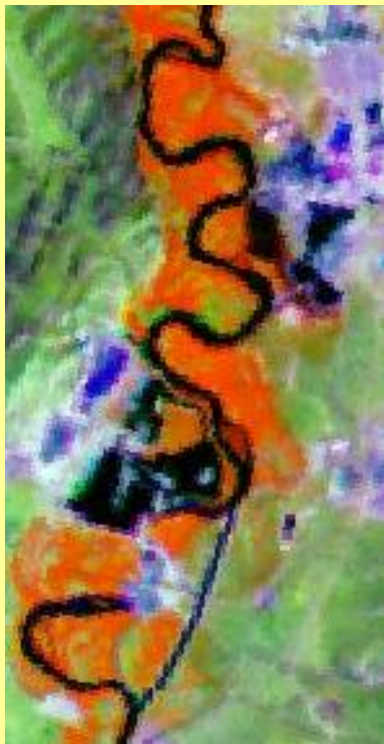
MINING ON THE FLOODPLAIN AND TERRACES ...

The lush wet grasslands (red) of the floodplain are being lost by placer mining. The image shows a river diversion to allow mining of the original

channel. Nearby are flooded pits (dark blue) on the floodplain, with spoil mounds adjacent.

The higher Toson Terraces on the right (east) are being dry mined (lilac and whitish blue), with small flooded pits and flooded tailings ponds (dark blue).

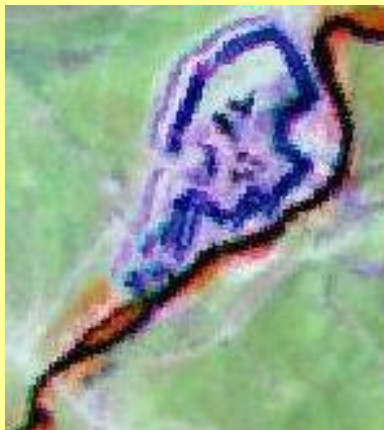
GOLD DREDGE ...

The anticlockwise path of the [South Dredge](#) is visible (medium blue), its dredge pond being medium blue with dumped oversize visible as a faint hairline trace. Elongate spoil mounds are visible (lilac and pale blue) dumped by large draglines.

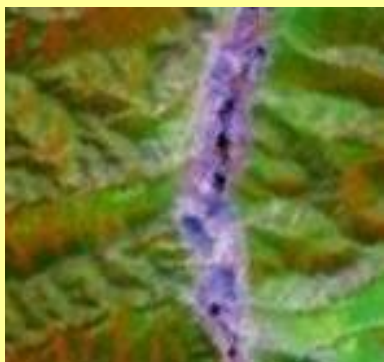
REHABILITATION ?

The floor of the narrow Hailaast Valley has being destroyed and strewn with dry pits, wet pits, conical and linear overburden mounds, tailings ponds and oversize mounds. No rehabilitation is visible.
